Final Removal Action Report

Mansfield Trail Dump Site
Stanhope-Sparta Rd
Byram Township, Sussex County, New Jersey

Removal Support Team 2
Weston Solutions, Inc.
Northeast Division
Edison, New Jersey

January 2013

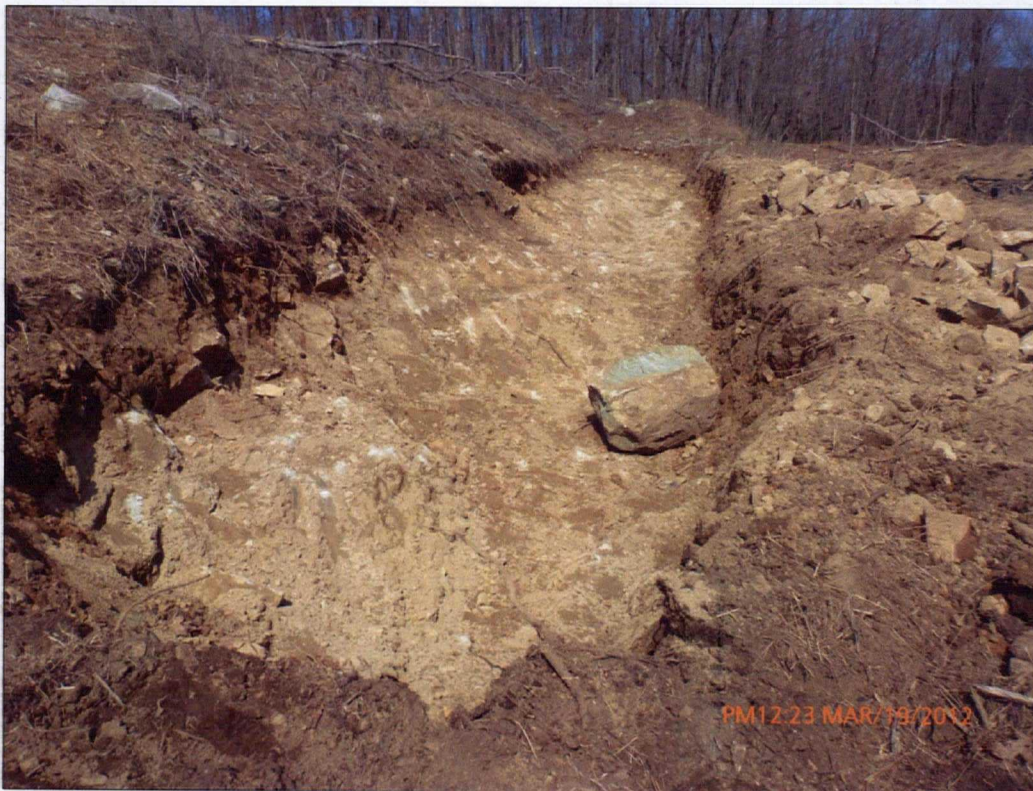
Photograph 4: A view of Dump Area D Trench 4 excavated to bedrock, taken on 3/19/12 at 1223 hrs.

Dump Area D: Trench 4 was excavated to bedrock from March 26 to 27, 2012. Trench 3 was excavated from March 28 to April 18, 2012. Trench 2 was excavated from April 21 to May 11, 2012. Trench 1 and lower Dump Area D, near roadway, was excavated from May 8 to 23, 2012. All material was stockpiled in the south section of Dump Area E. The excavator operator separated sulfide reactive containing non-hazardous material from non-sulfide reactive containing non-hazardous material based on previous sampling results.

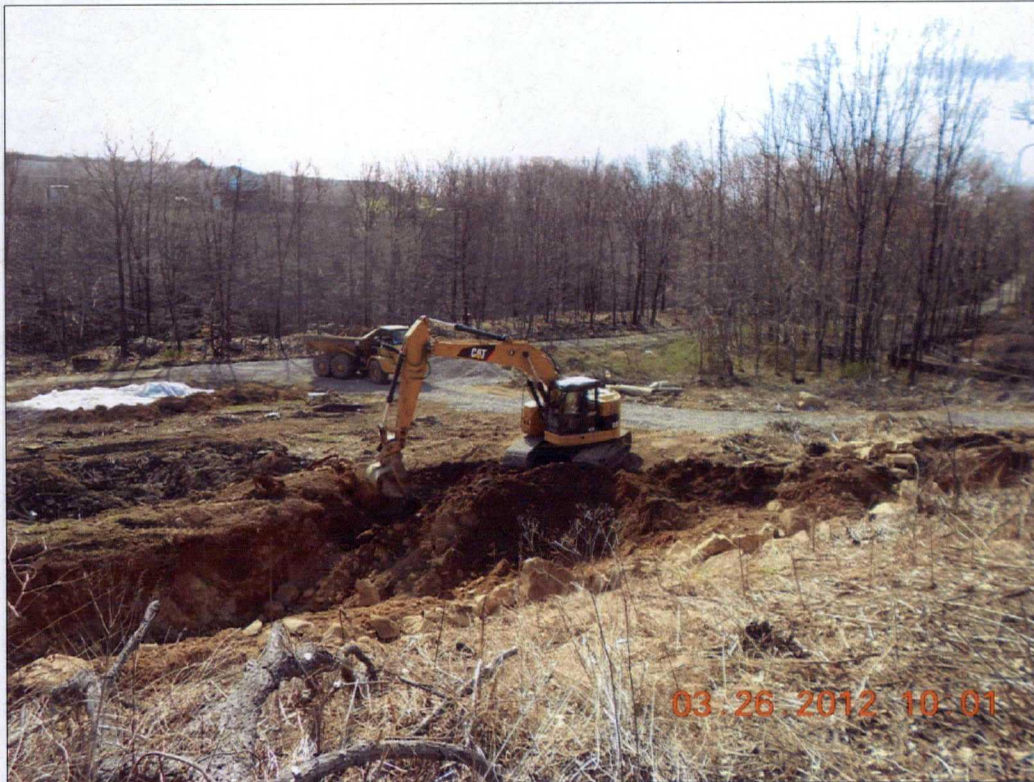
Photograph 5: A view of Dump Area D excavation of Trench 3, taken on 3/26/12 at 1001 hrs.

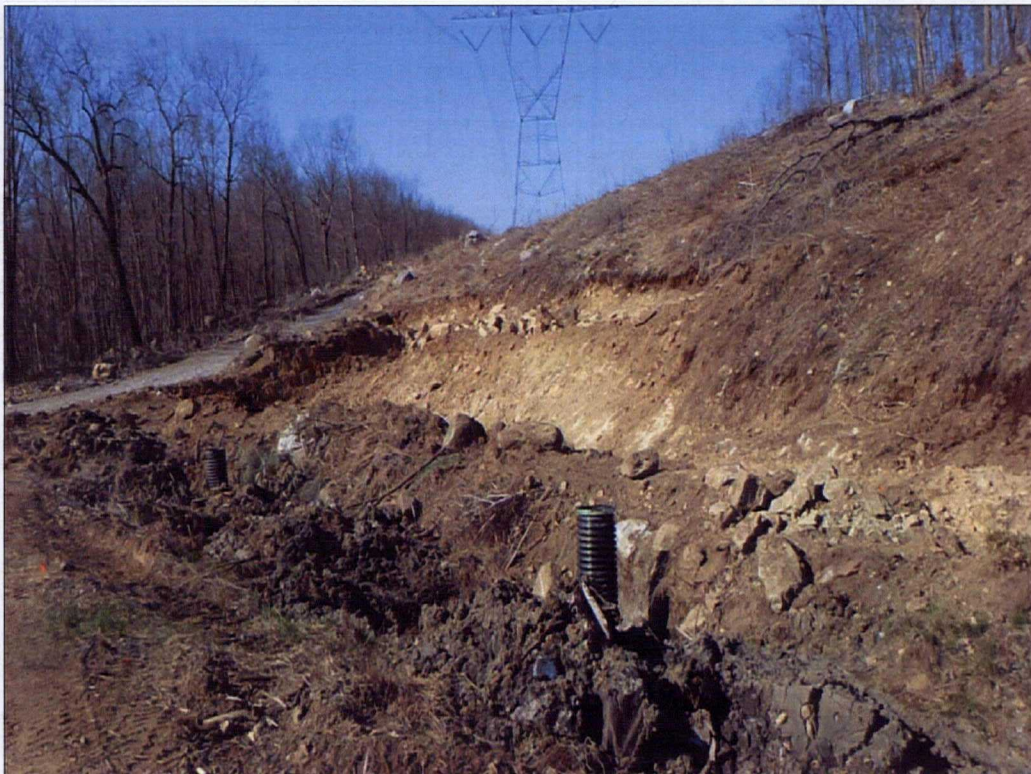
Photograph 6: A view of Dump Area D completed excavation of the South end of Trench 3 and the sumps in Trench 2, taken on 3/27/12 at 0947 hrs.

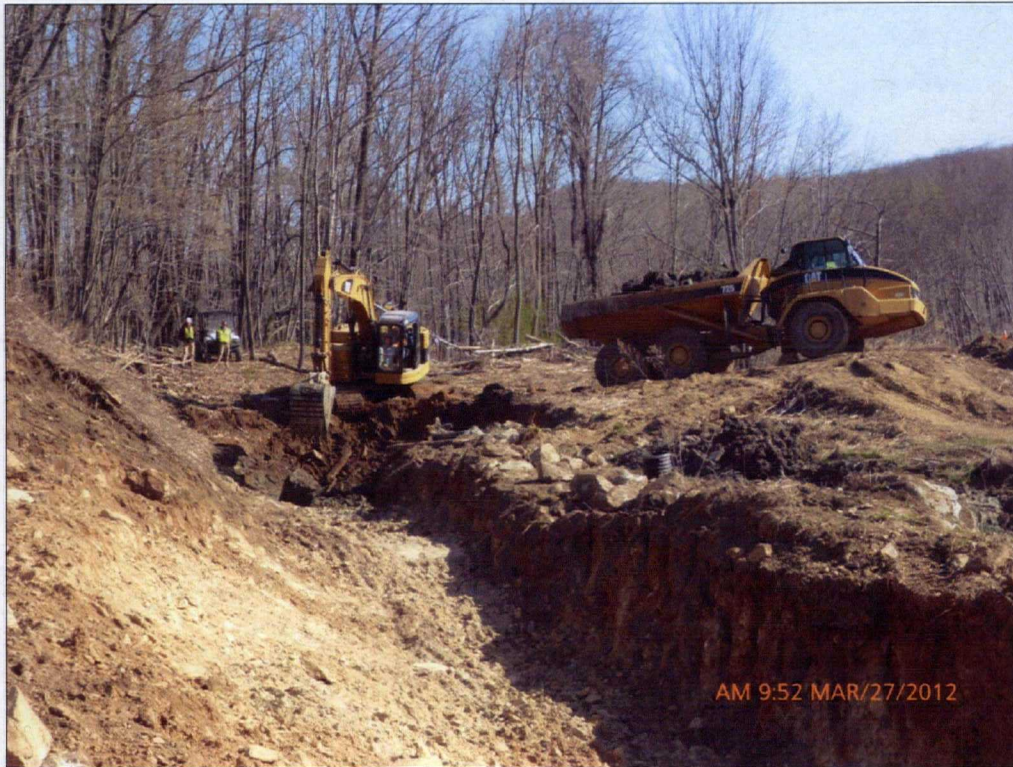
Photograph 7: A view of Dump Area D excavation in the northern section of Trench 3, taken on 3/27/12 at 0952 hrs.

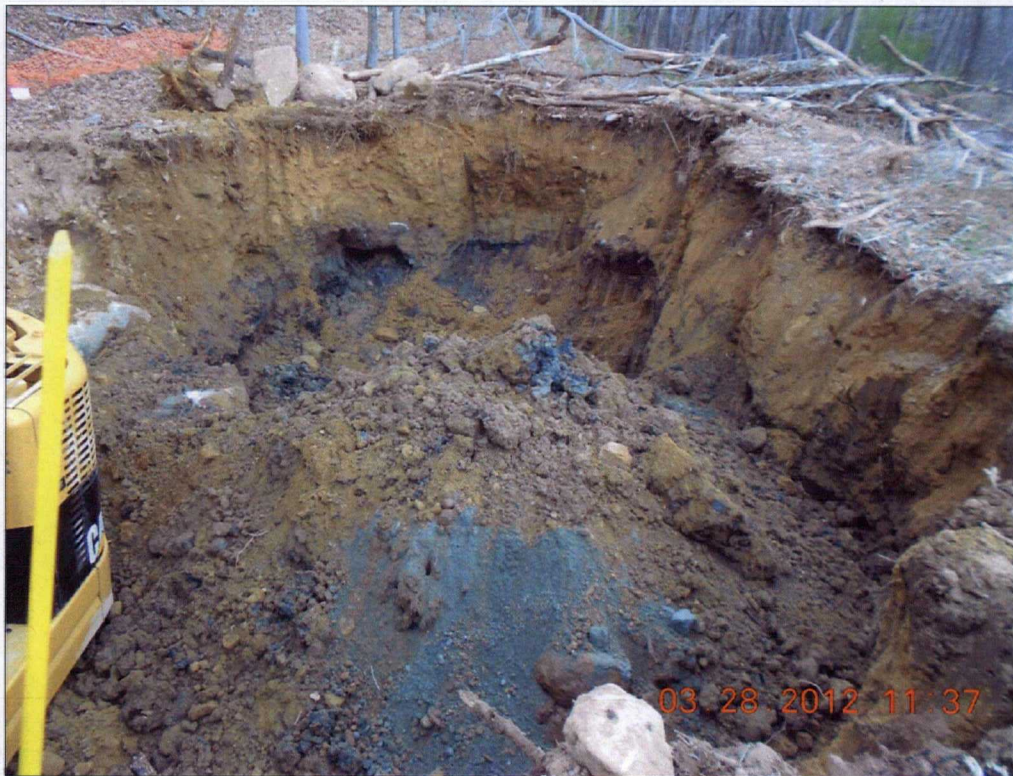
Photograph 8: A view of Dump Area D excavation of the black material in the northern section of Trench 3, taken on 3/28/12 at 1137 hrs.

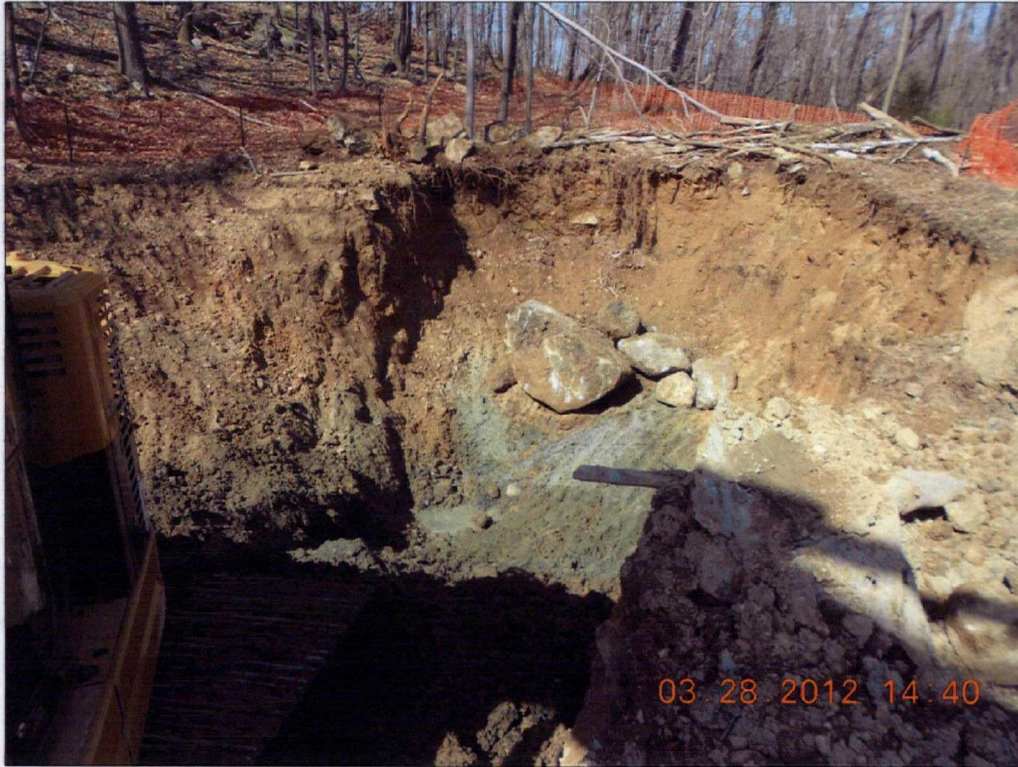
Photograph 9: A view of Dump Area D, taken by ERRS operator from excavator cab at the northern section of Trench 3 following the removal of the black material, taken on 3/28/12 at 1440 hrs.

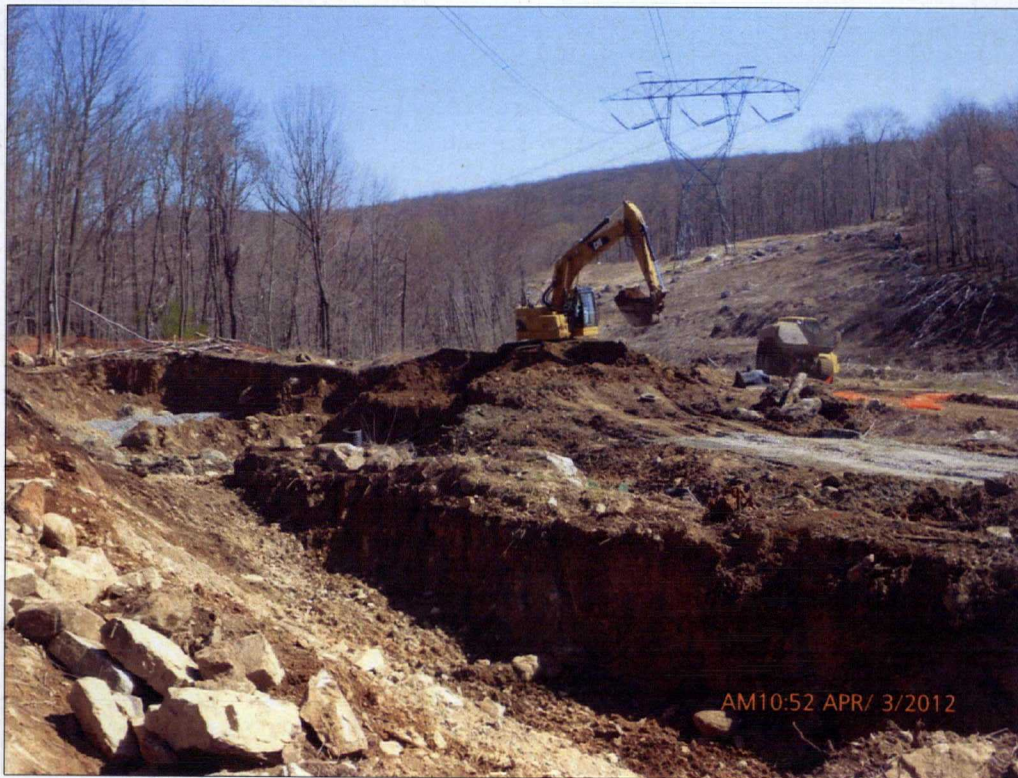
Photograph 10: A view of Dump Area D, excavation material from Trench 3, taken on 4/3/12 at 1052 hrs.

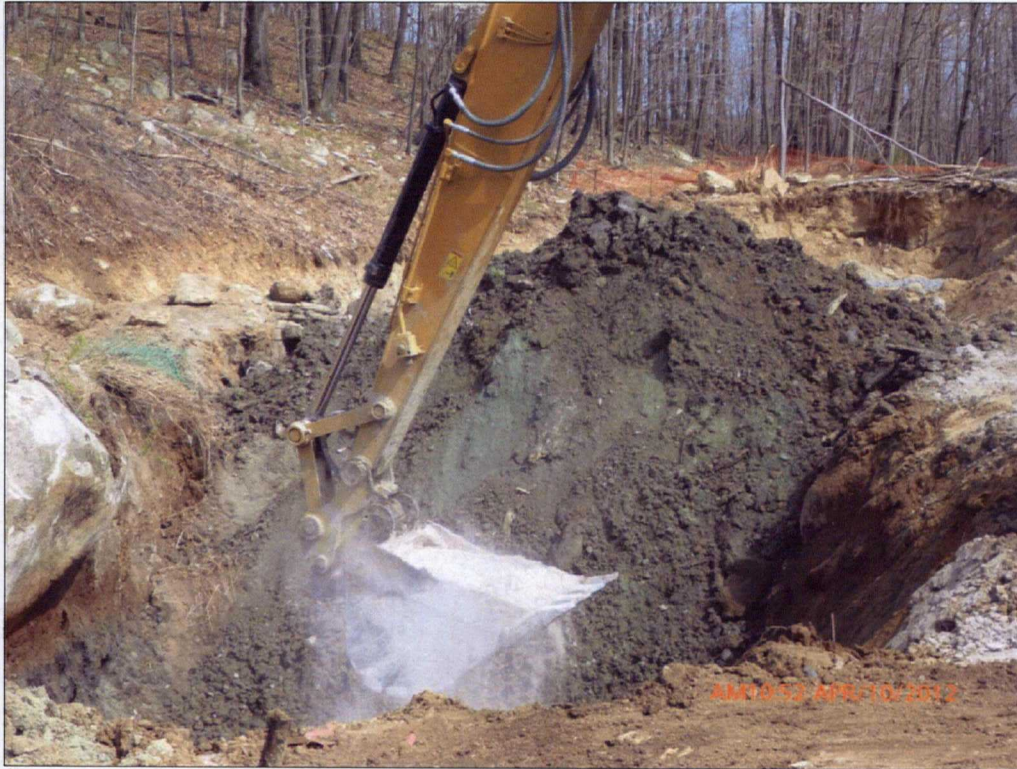
Photograph 11: A view of Dump Area D, mixing kiln dust to bind material in Trench 2, taken on 4/10/12 at 1052 hrs.

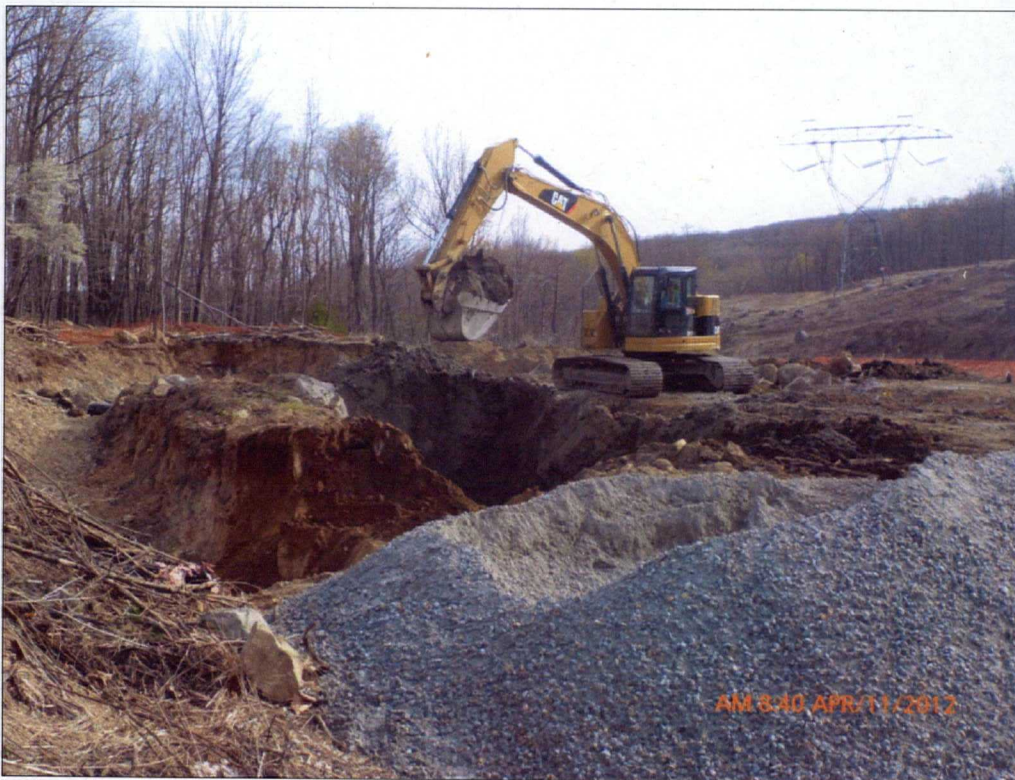
Photograph 12: A distant view of Dump Area D and material excavation in Trench 2, taken on 4/11/12 at 0840 hrs.

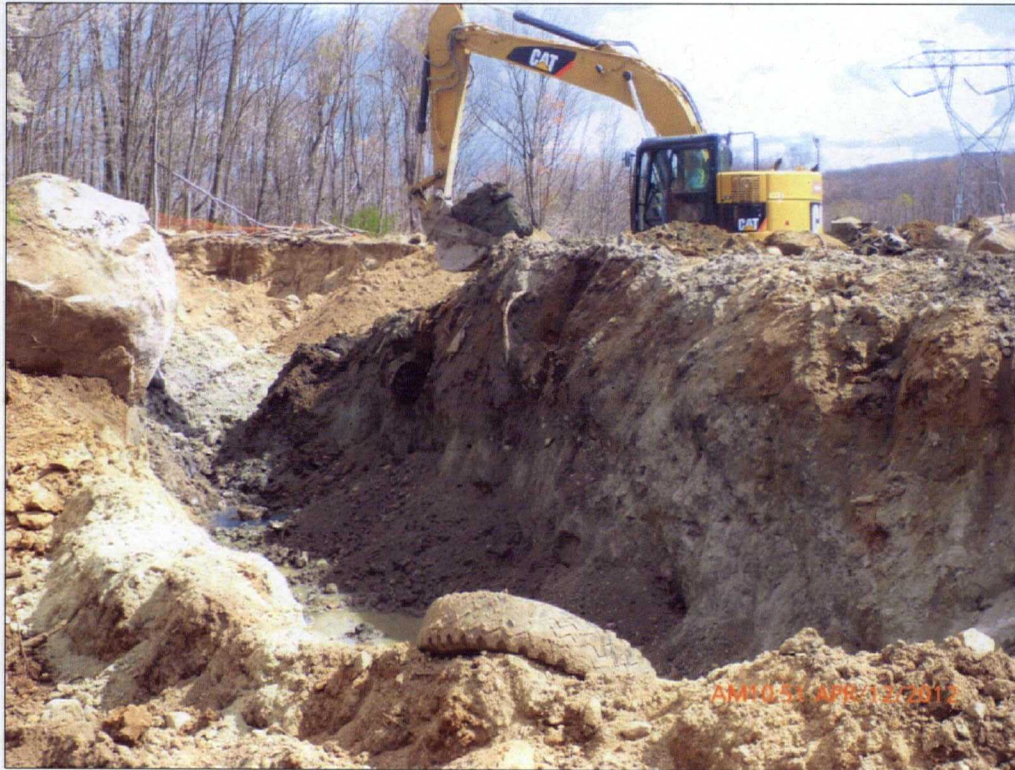
Photograph 13: A close view of Dump Area D and material excavation in Trench 2, taken on 4/12/12 at 1051 hrs.

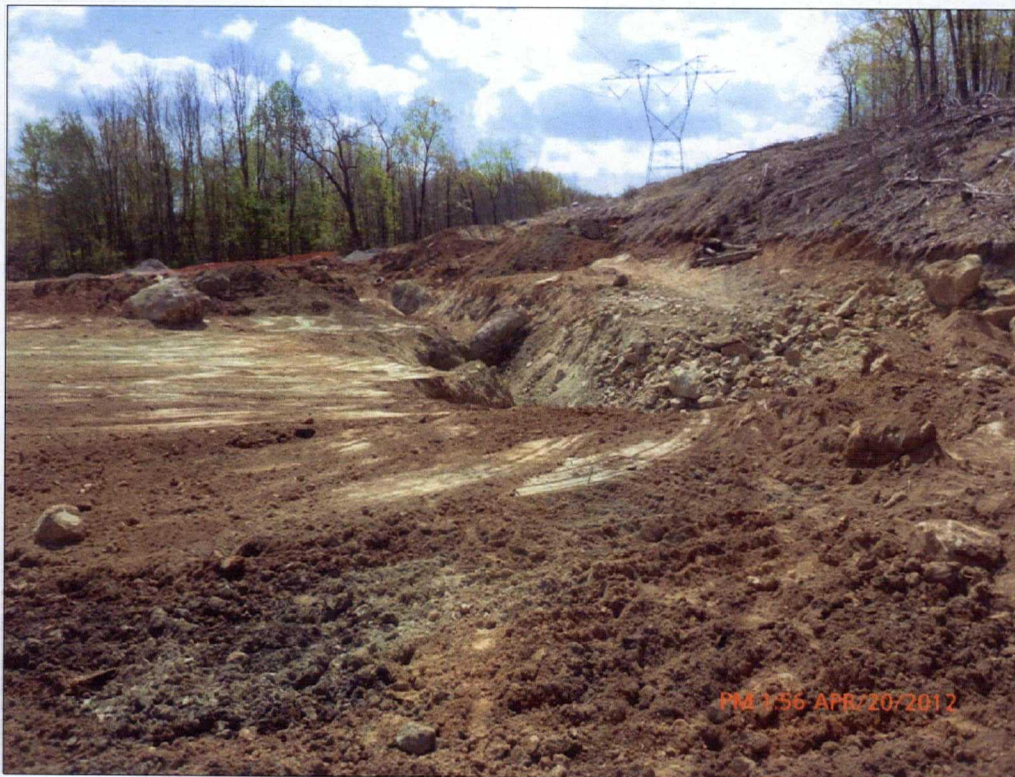
Photograph 14: A general view of Dump Area D excavation, taken on 4/20/12 at 1356 hrs.

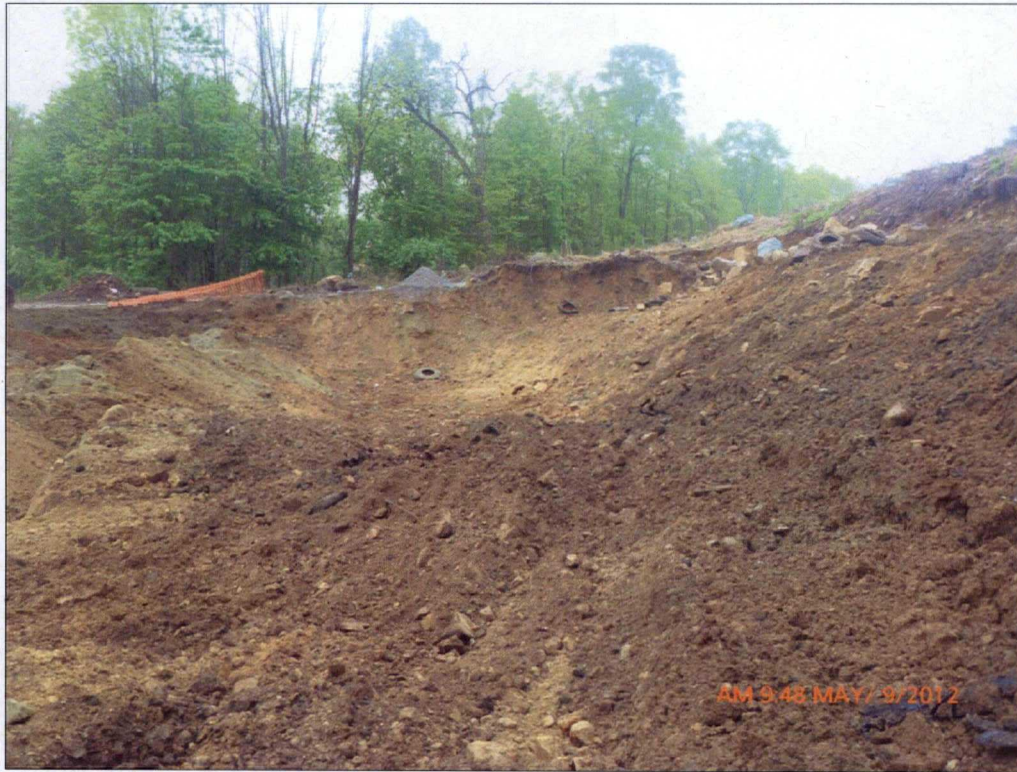
Photograph 15: A general view of Dump Area D excavation, taken on 5/9/12 at 0948 hrs.

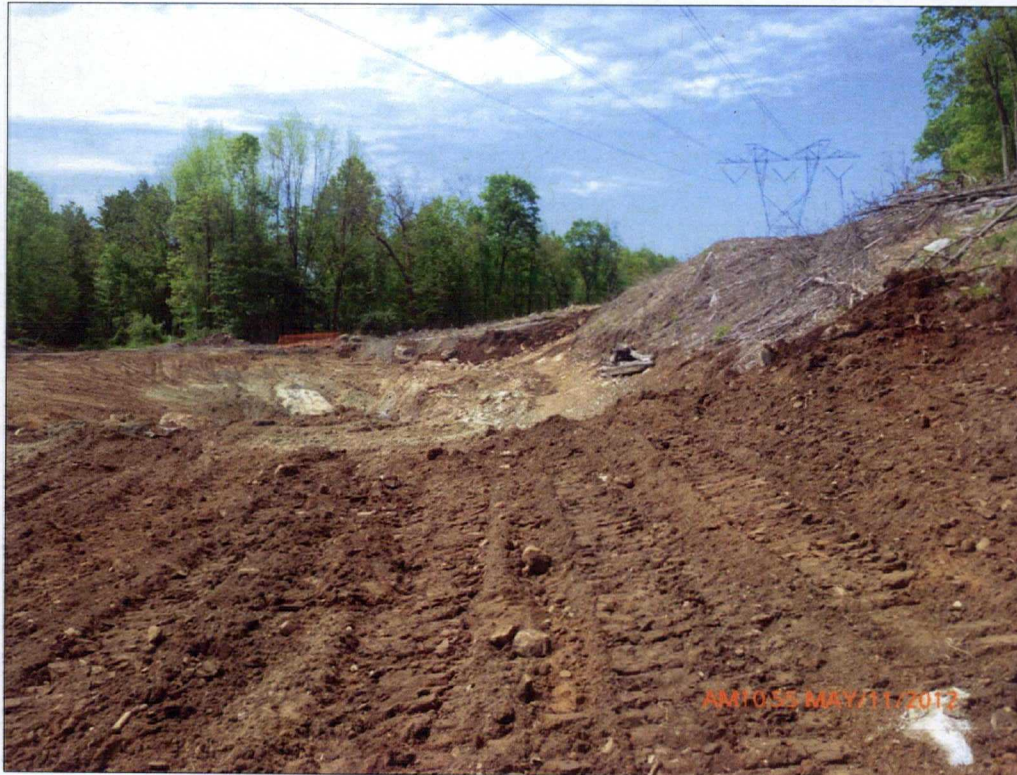
Photograph 16: A general view of Dump Area D backfilling and grading, taken on 5/11/12 at 1055 hrs.

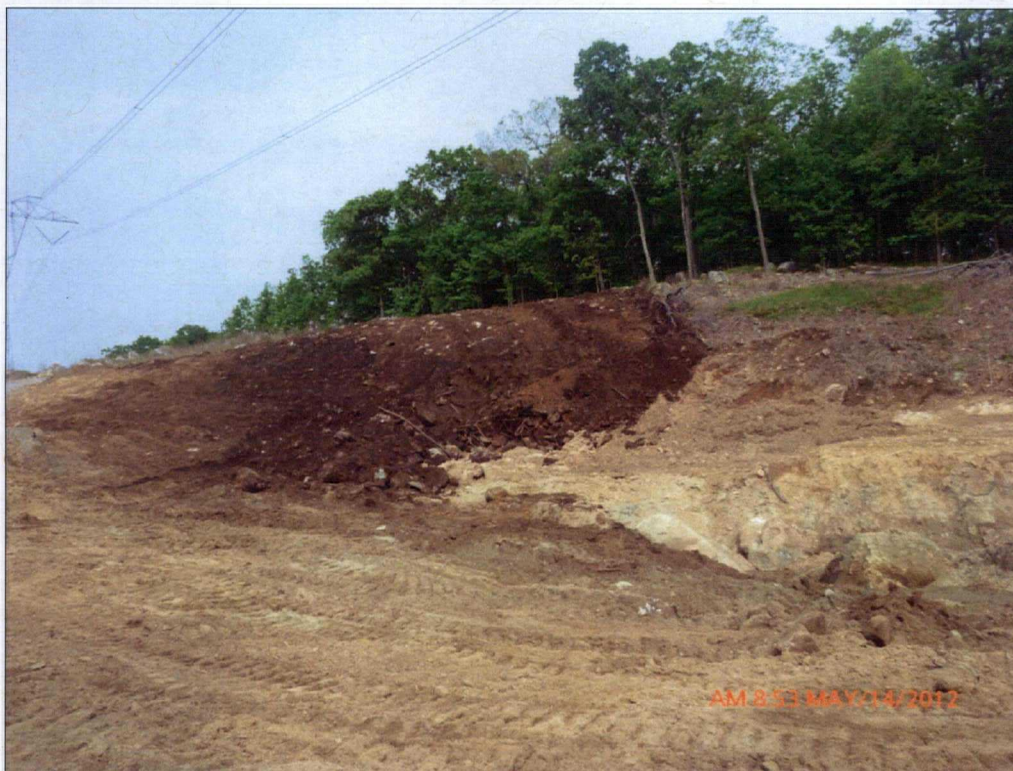
Photograph 17: A general view of Dump Area D, backfilling and grading, taken on 5/14/12 at 0853 hrs.

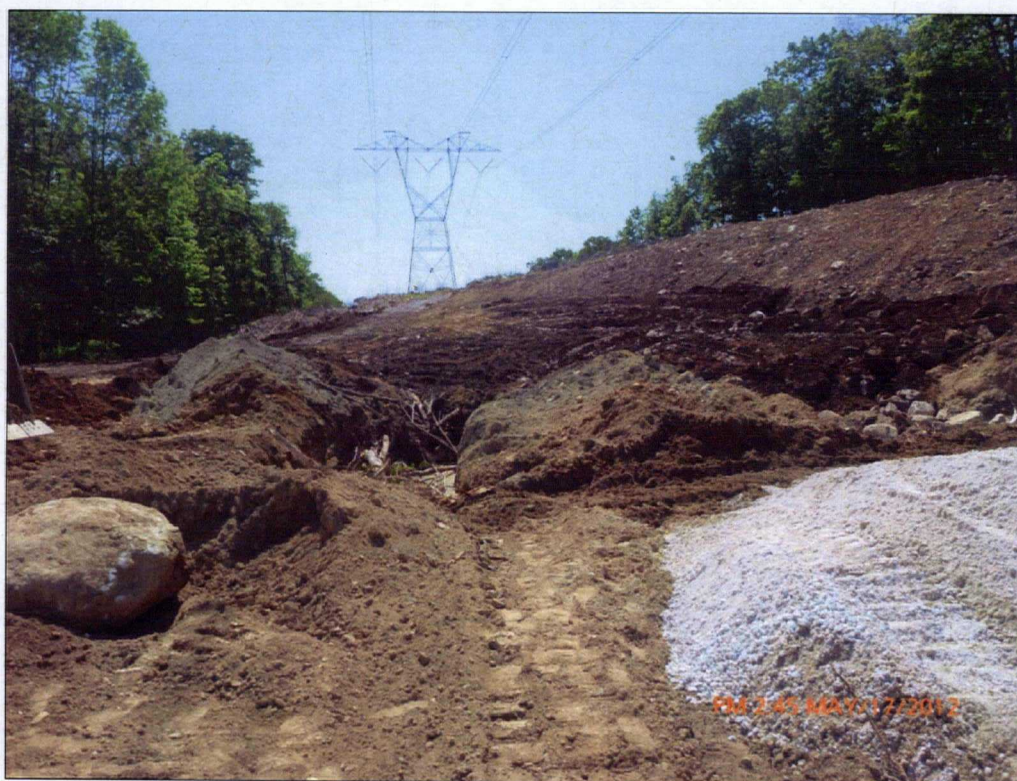
Photograph 18: A general view of Dump Area D, backfilling and grading, taken on 5/17/12 at 1445 hrs.

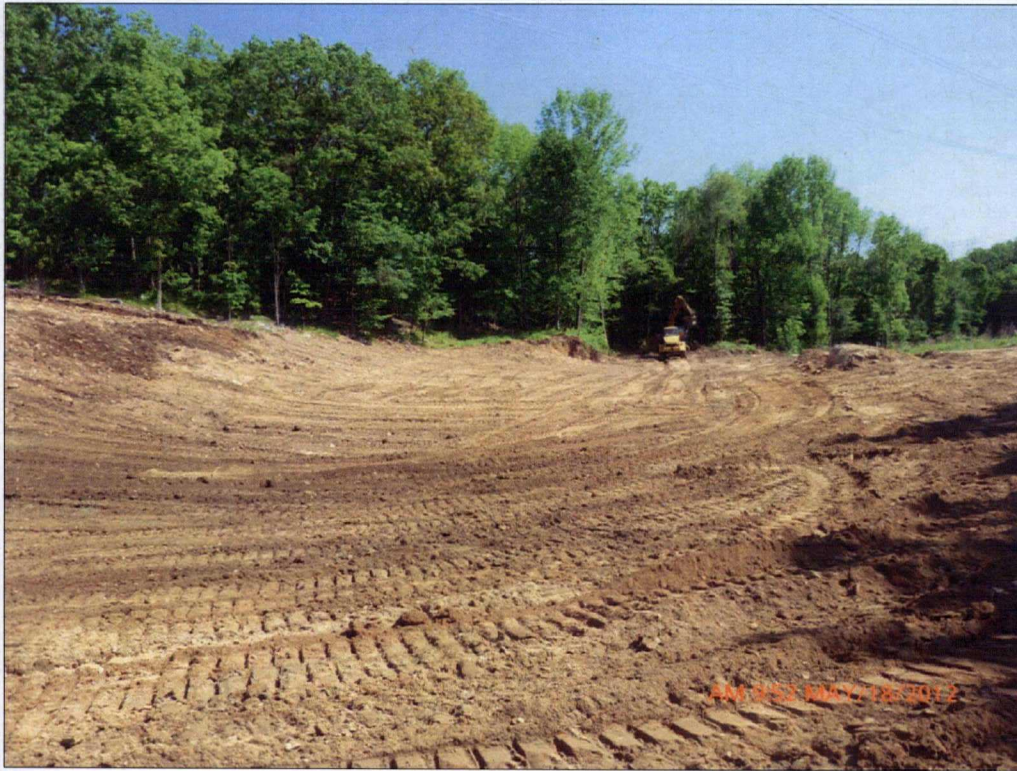
Photograph 19: A general view of Dump Area D grading, taken on 5/18/12 at 0952 hrs.

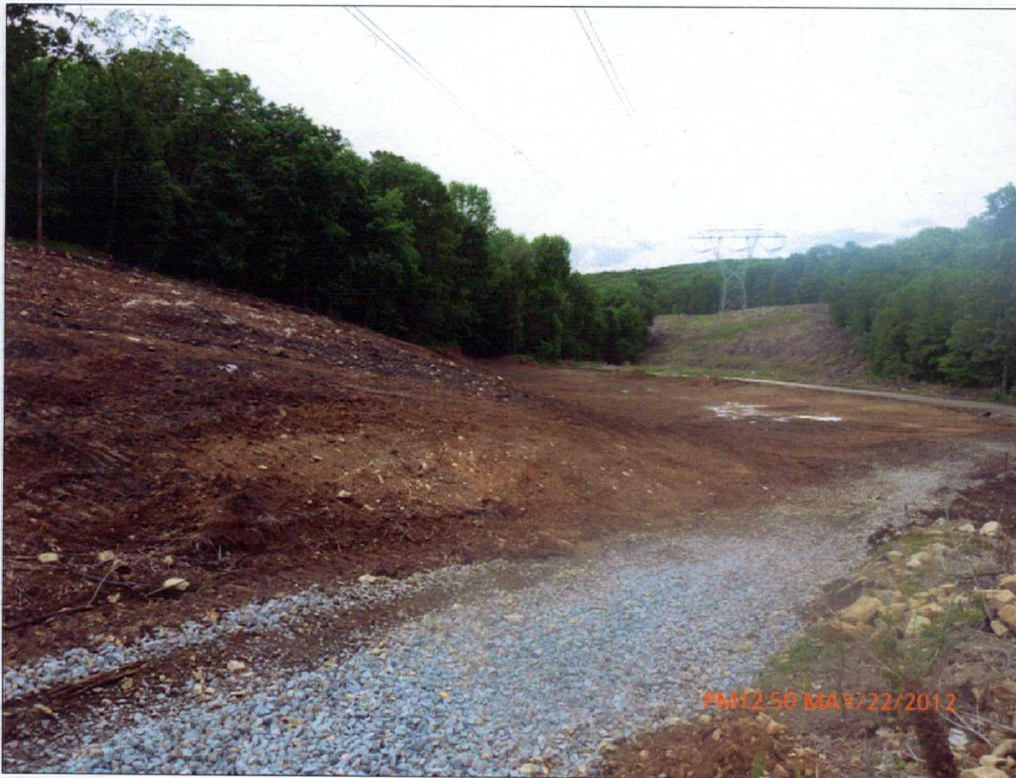
Photograph 20: A view of Dump Area D and completed removal activities, taken on 5/22/12 at 1250 hrs.

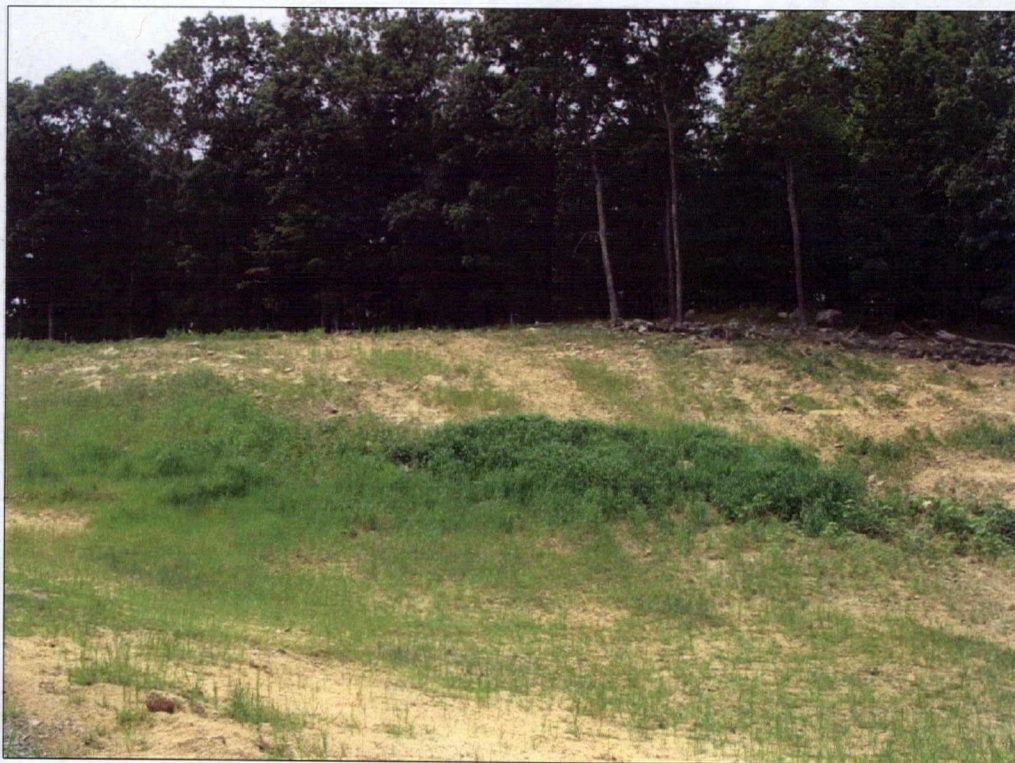
Photograph 24: A general view of Dump Area D post restoration facing Northwest, taken on 7/13/12 at 1317.

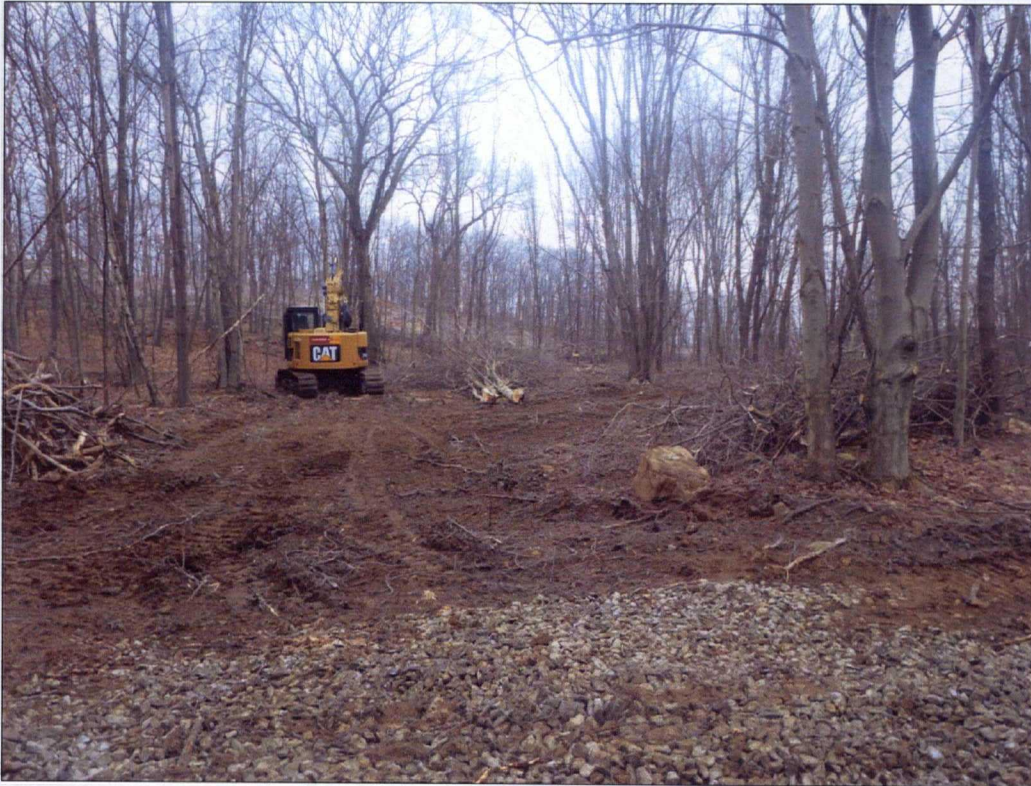
Photograph 1: A view of Dump Area E prior to removal activities, taken on 2/17/12 at 0905 hrs.

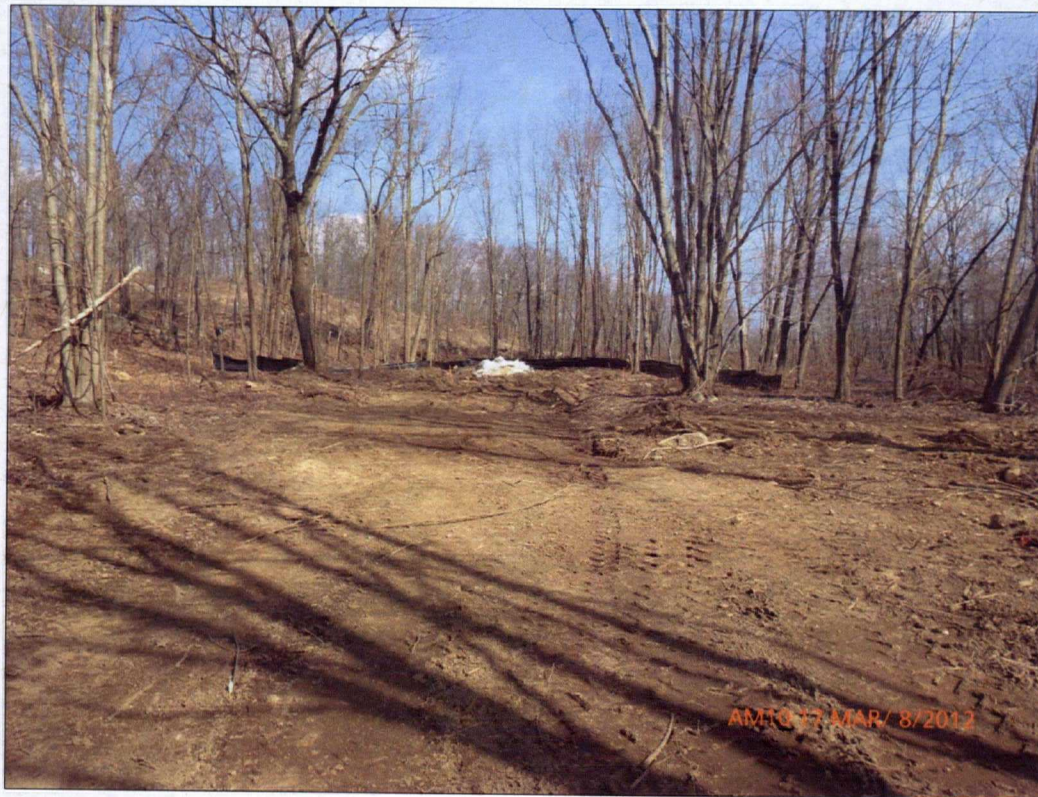
Photograph 2: A view Dump Area E after grading and preparation for stock piles, taken on 3/8/12 at 1017 hrs.

Dump Area E: From February 15 to 22, 2012, ERRS cleared trees from Dump Area E. From March 5 to 7, 2012, ERRS graded and prepared Dump Area E for staging of hazardous and non-hazardous waste. Two silt fences were installed to prevent run off from excavated stock piled material.

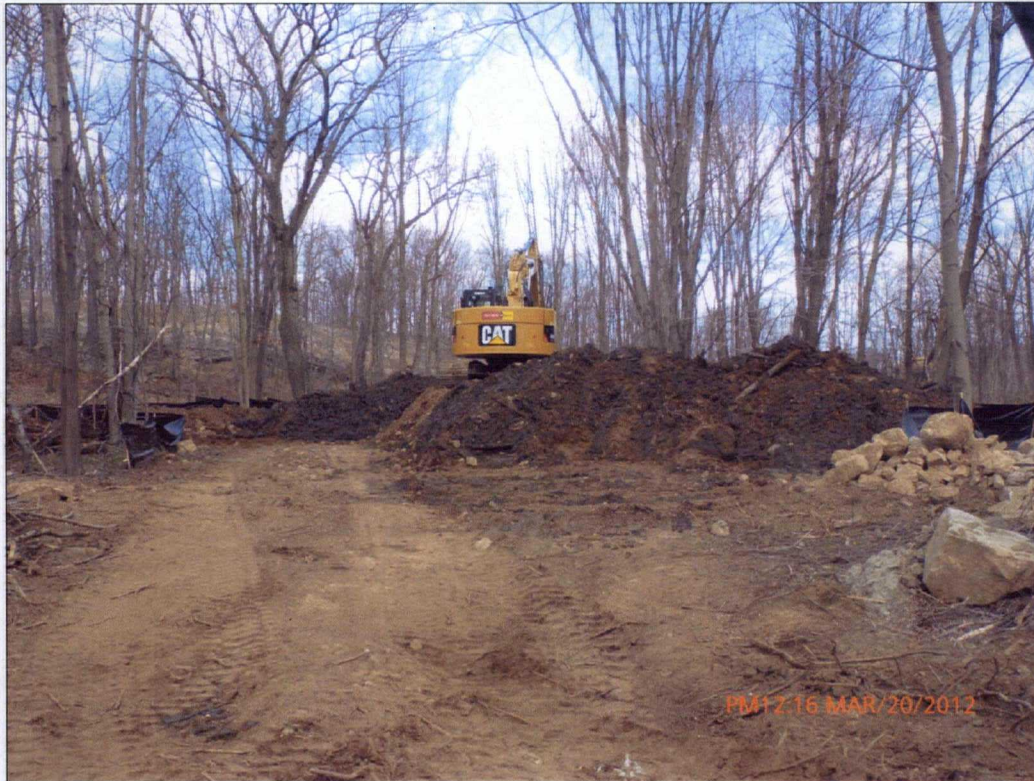
Photograph 3: A view of Dump Area E hazardous stock pile in staging area, taken on 3/20/12 at 1216 hrs.

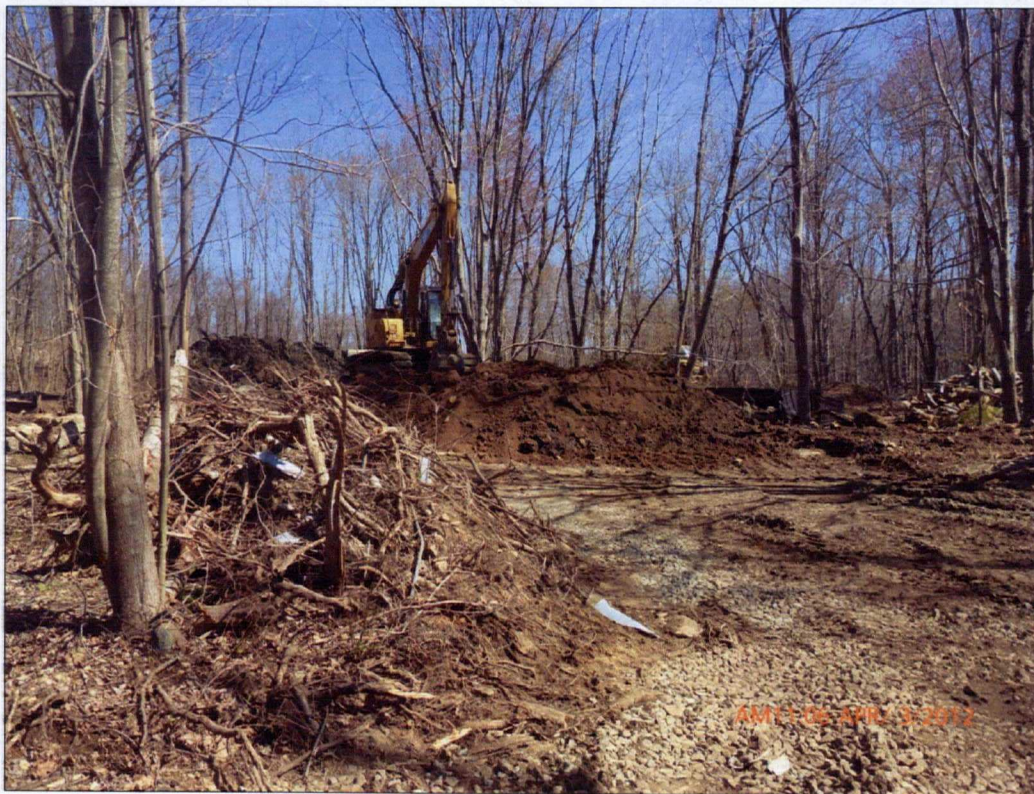
Photograph 4: A view of Dump Area E non-hazardous stock pile in staging area, taken on 4/3/12 at 1106 hrs.

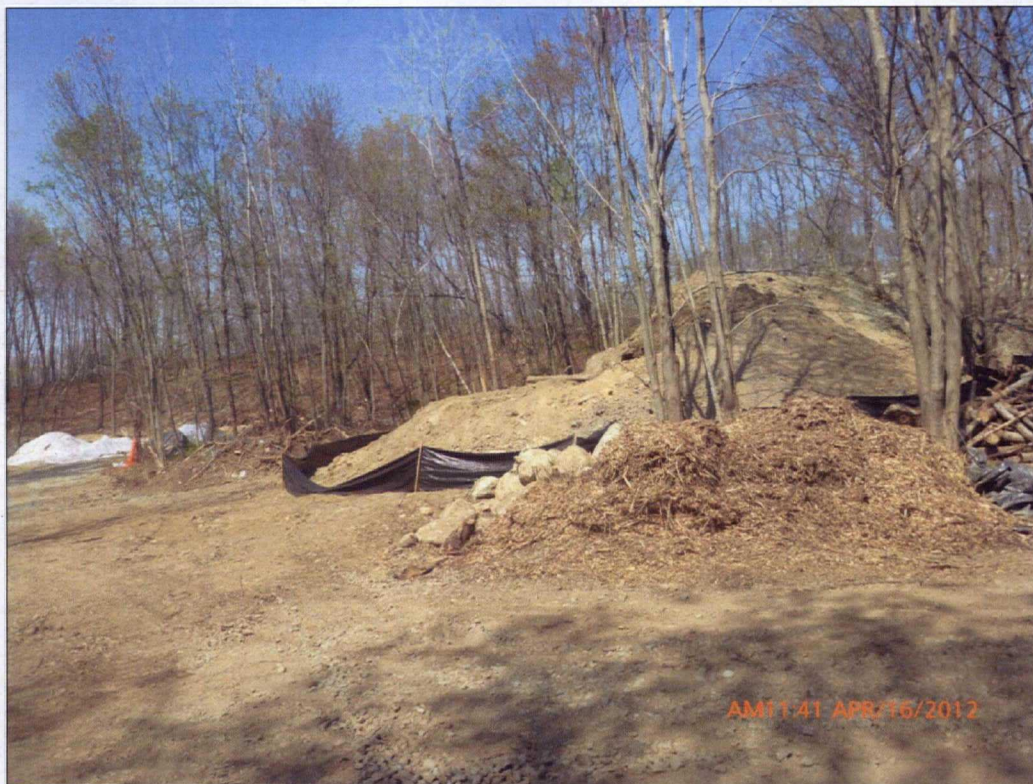
Photograph 5: A view of Area E non-hazardous materials stock pile in staging area, taken on 4/16/12 at 1141 hrs.

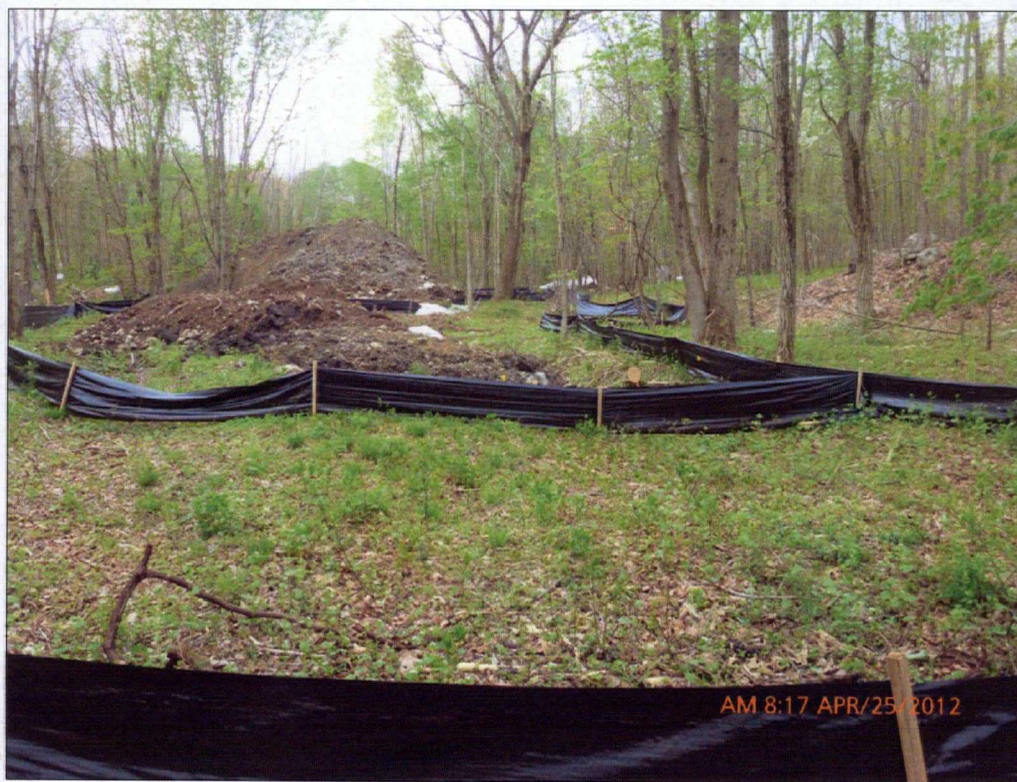
Photograph 6: A view of Area E non-hazardous (rear) and hazardous (front) stock piles staging area, taken on 4/25/12 at 0817 hrs.

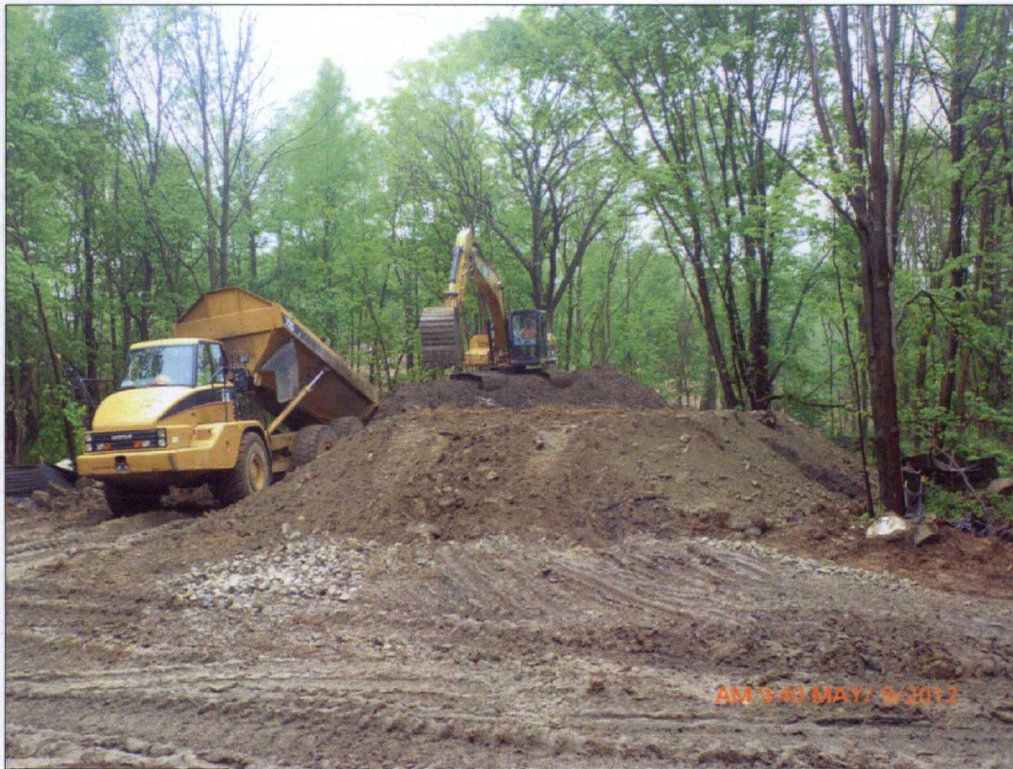
Photograph 7: A view of Dump Area E stock pile activities in staging area 3, taken on 5/9/12 at 0940 hrs.

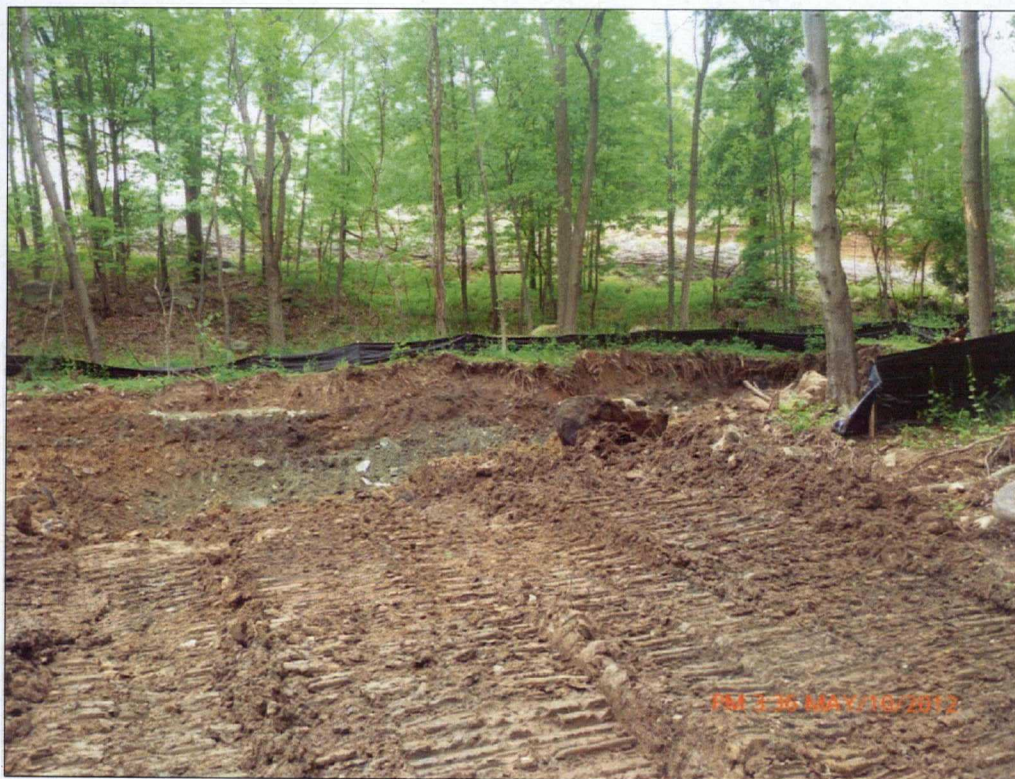
Photograph 8: A view of Dump Area E after the hazardous pile and material were removed, taken on 5/10/12 at 1318 hrs.

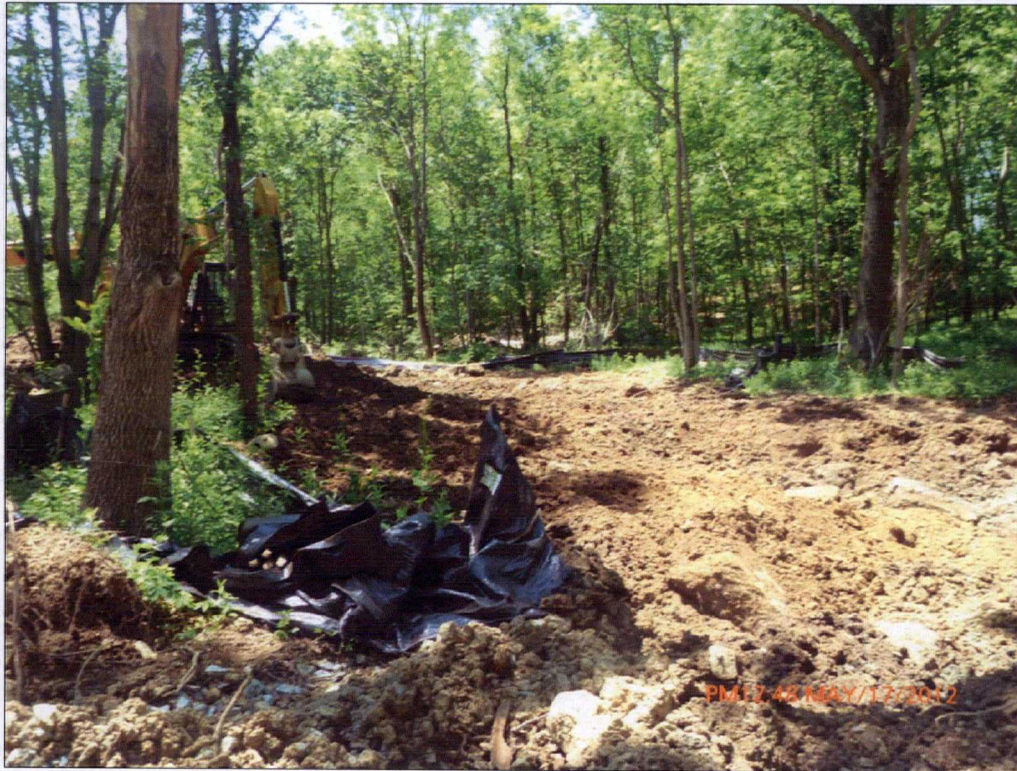
Photograph 9: A view of Dump Area E after stock piles were removed, including the removal of 2 to 3 feet of material below the piles, taken on 5/17/12 at 1248 hrs.

Dump Area E: From March 8 to May 21, 2012, Dump Area E was used as a staging area for the hazardous and non-hazardous materials stockpiles. From May 16 to 21, 2012, ERRS excavated to bedrock (approximately two to three feet of material) where the non-hazardous material stockpile was located and excavated approximately 4 to 7 feet where the hazardous waste stockpile was located in Dump Area E.
